# NORTHRIDGE EARTHQUAKE: LIFELINE PERFORMANCE AND POST-EARTHQUAKE RESPONSE

Technical Council on  
Lifeline Earthquake Engineering,  
American Society of Civil Engineers

Edited by Anshel J. Schiff

April 1997

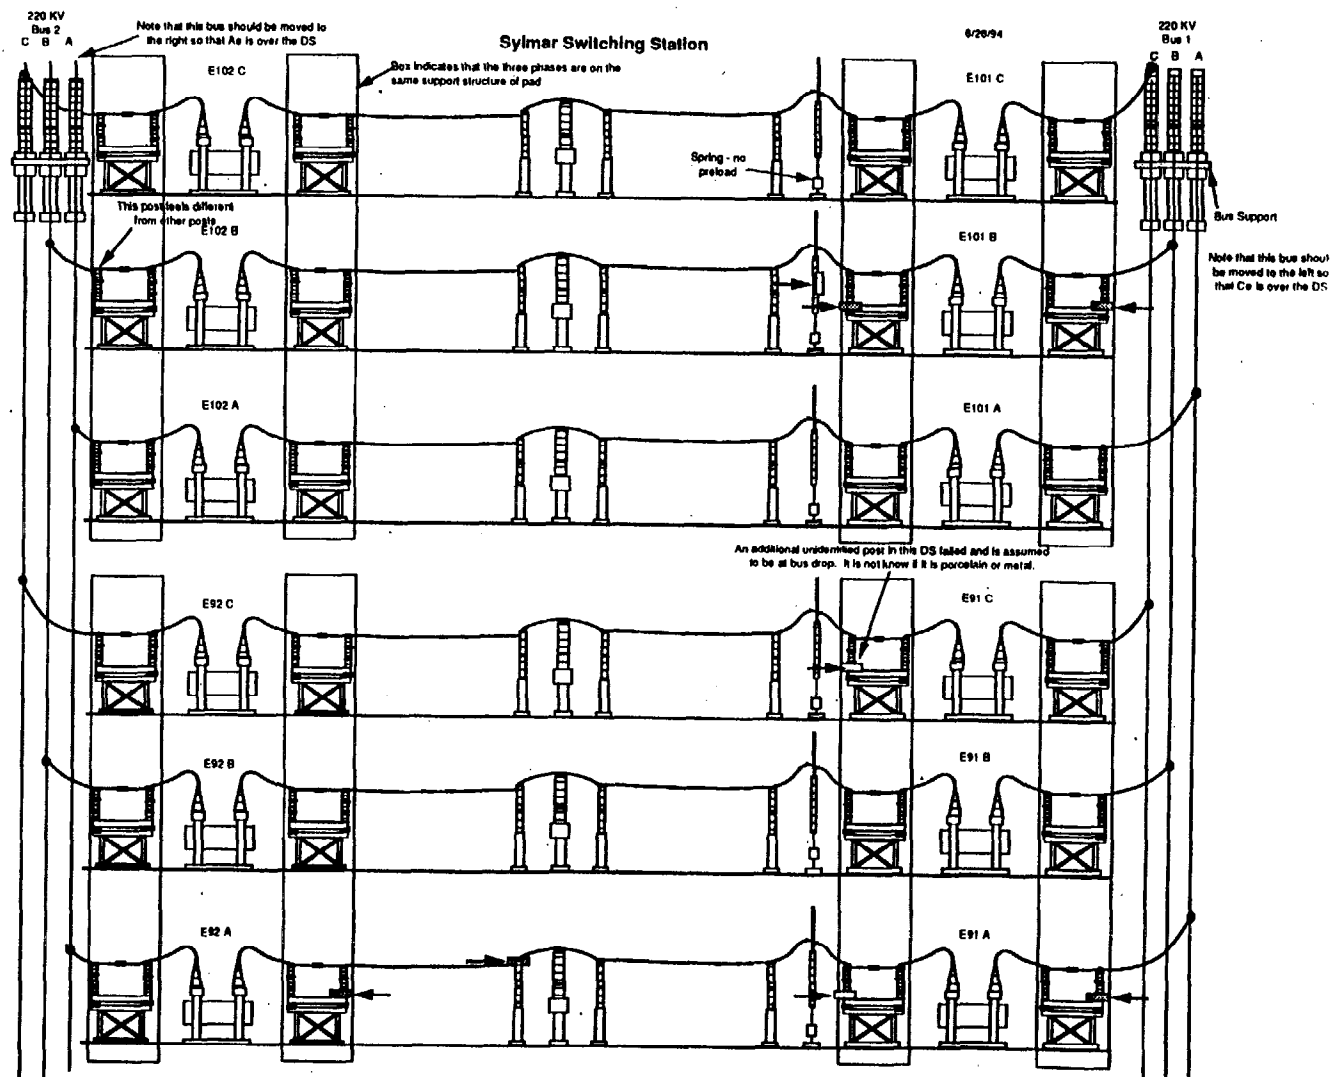
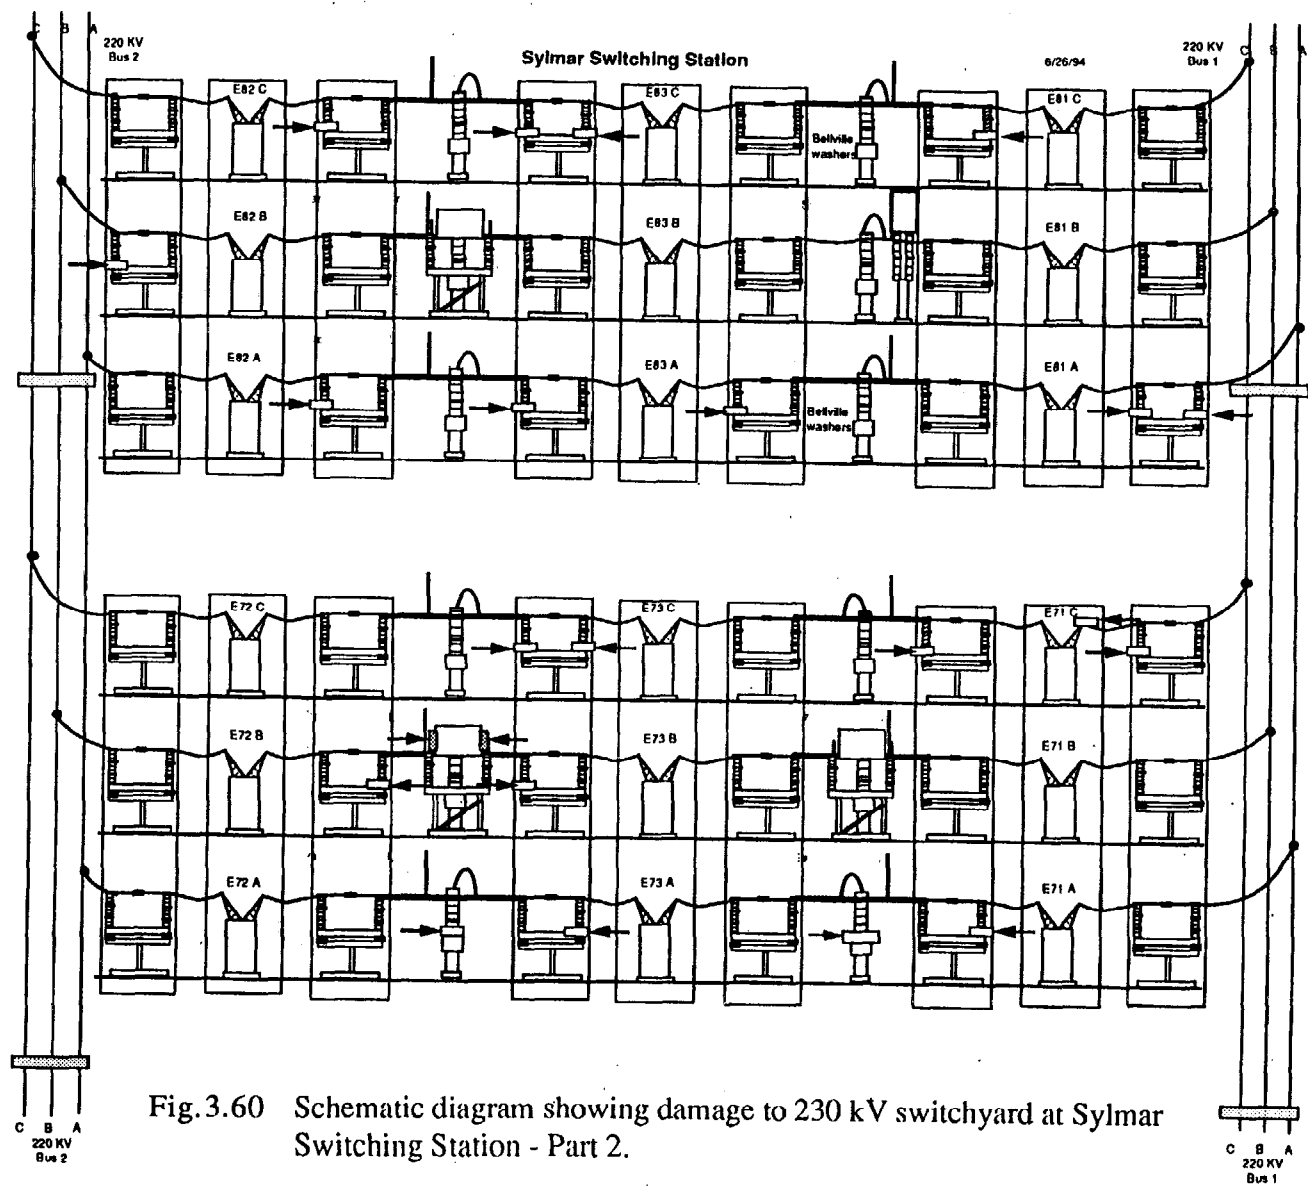
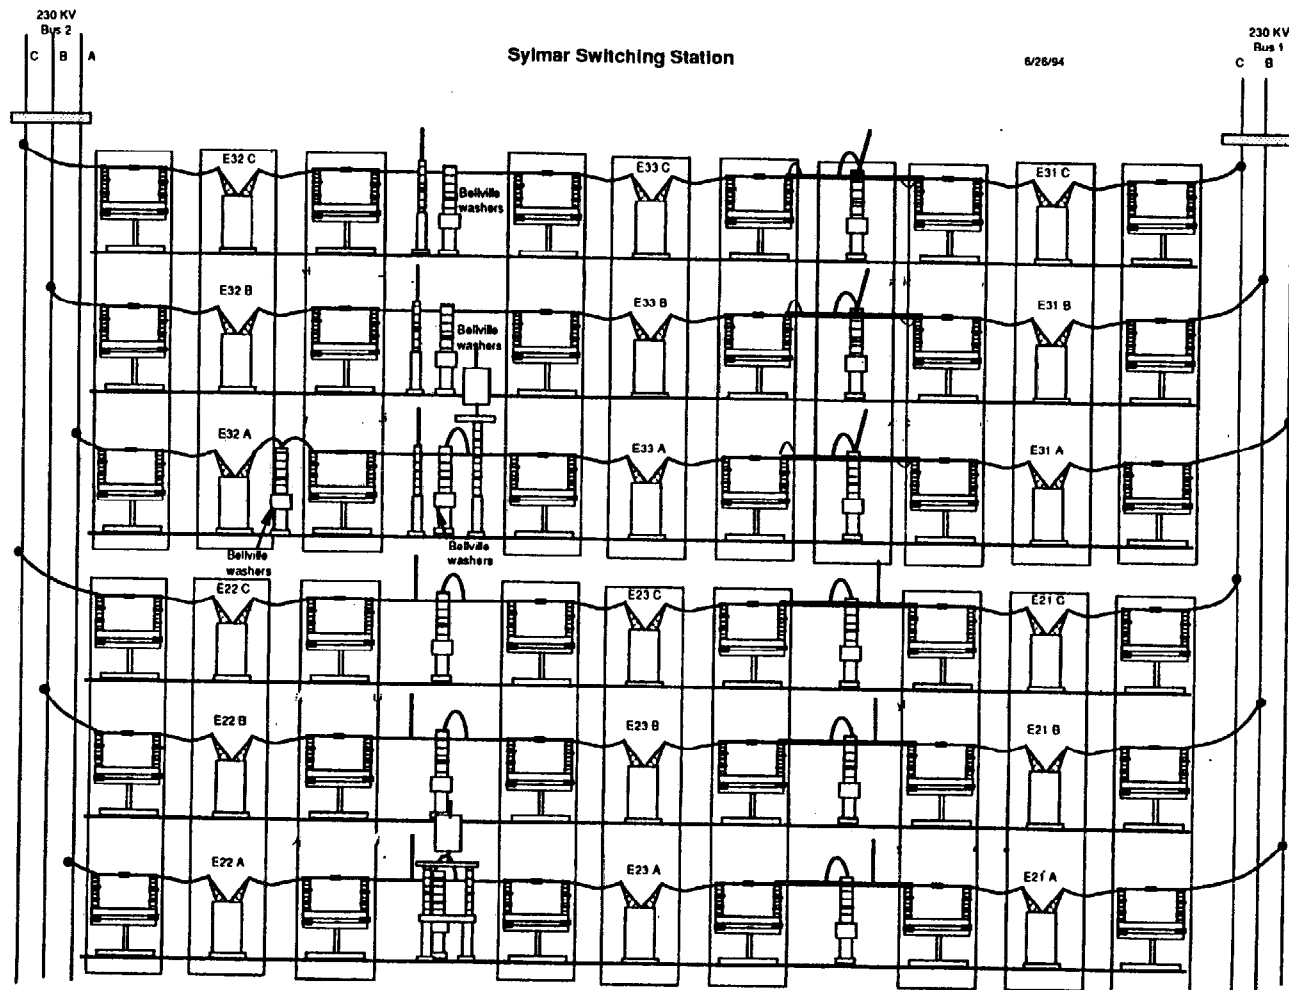
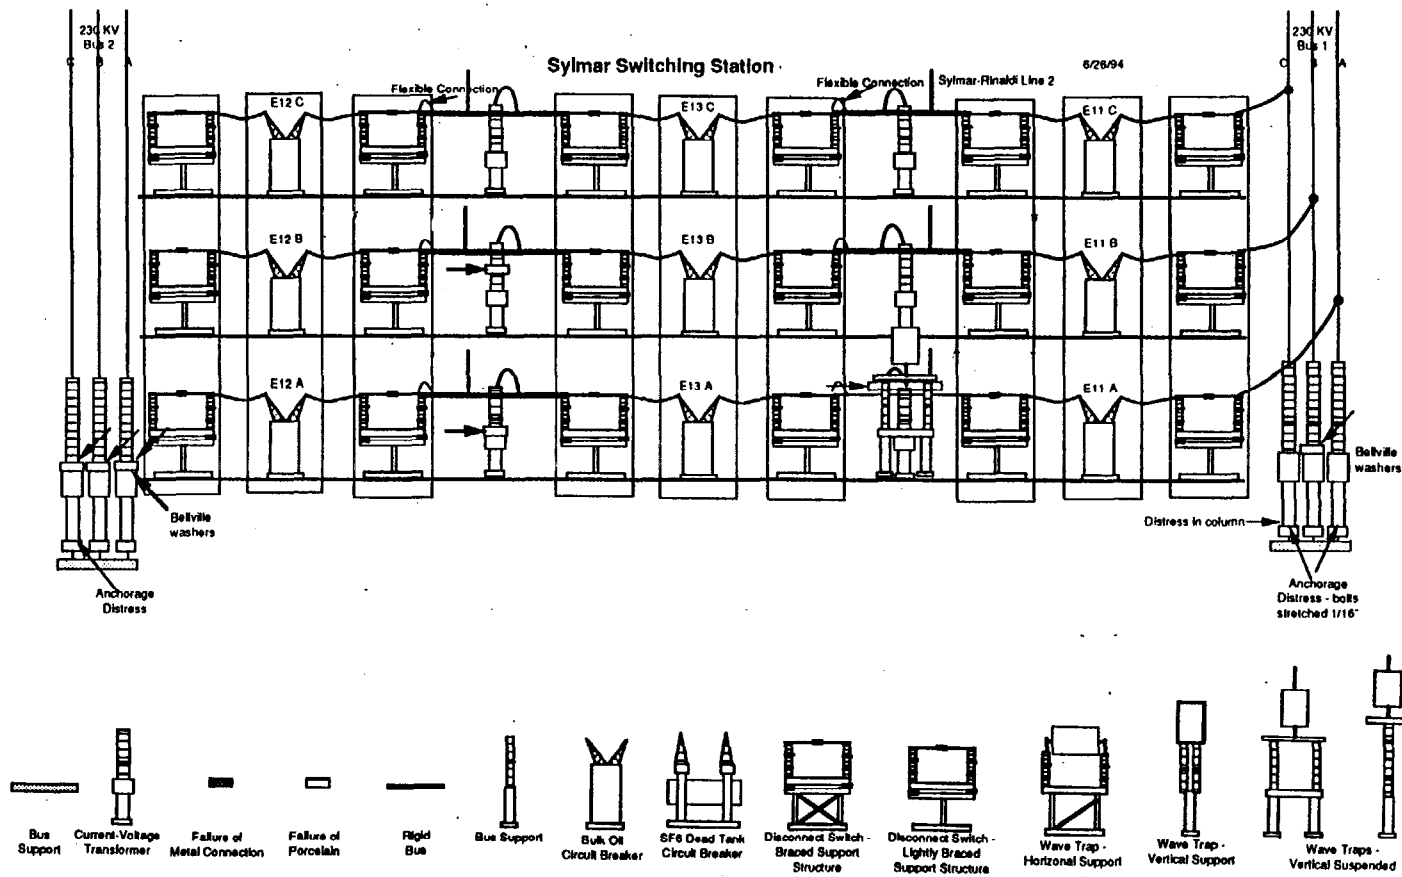
Fig. 3.60 Schematic diagram showing damage to 230 kV switchyard at Sylmar Switching Station - Part 1.

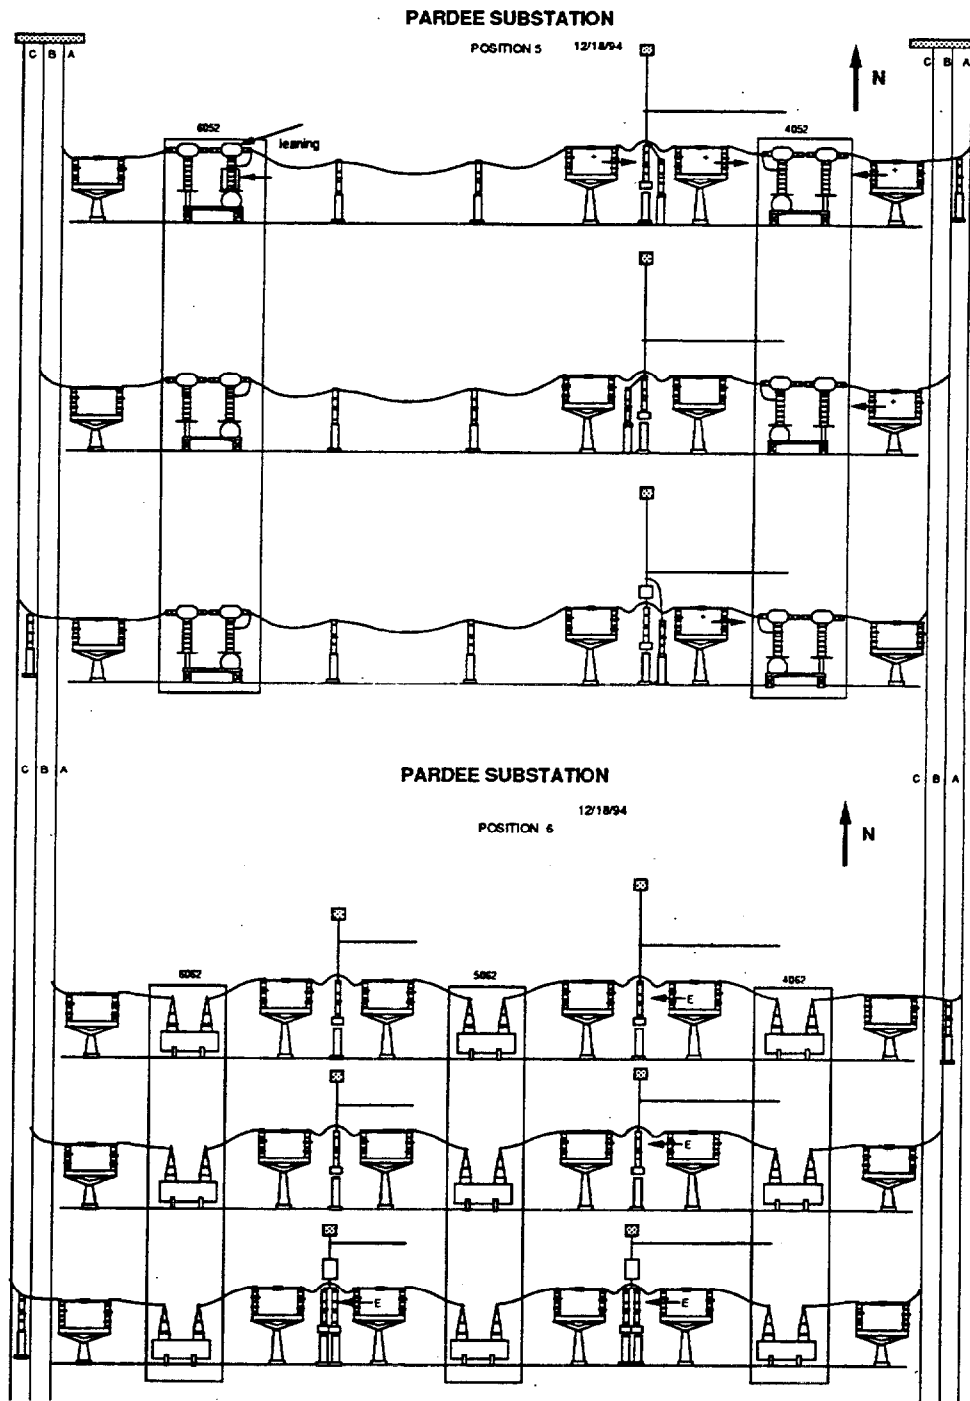
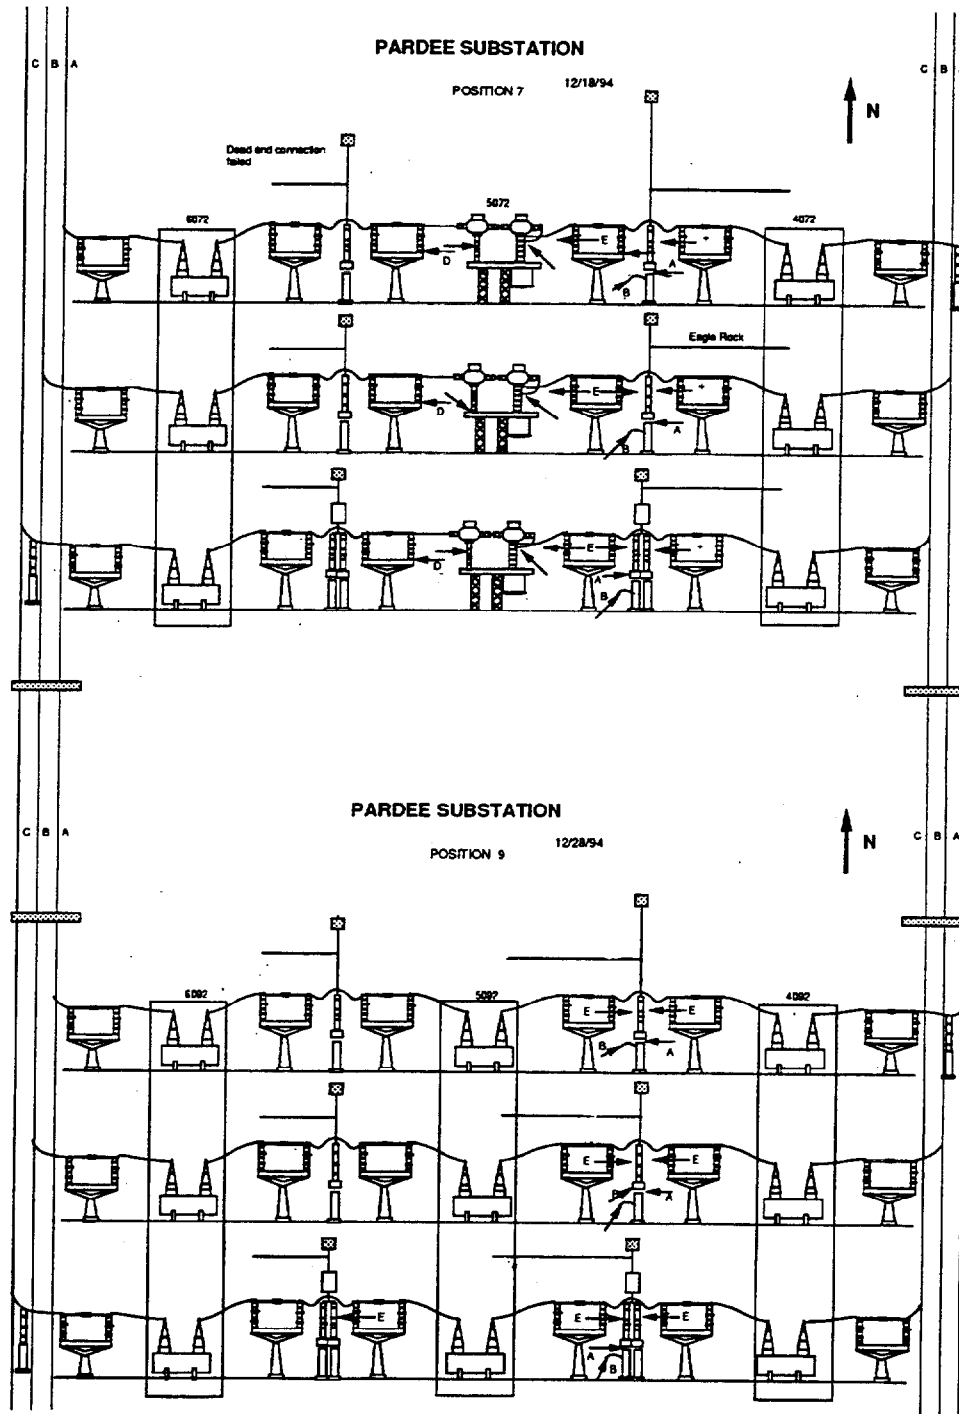
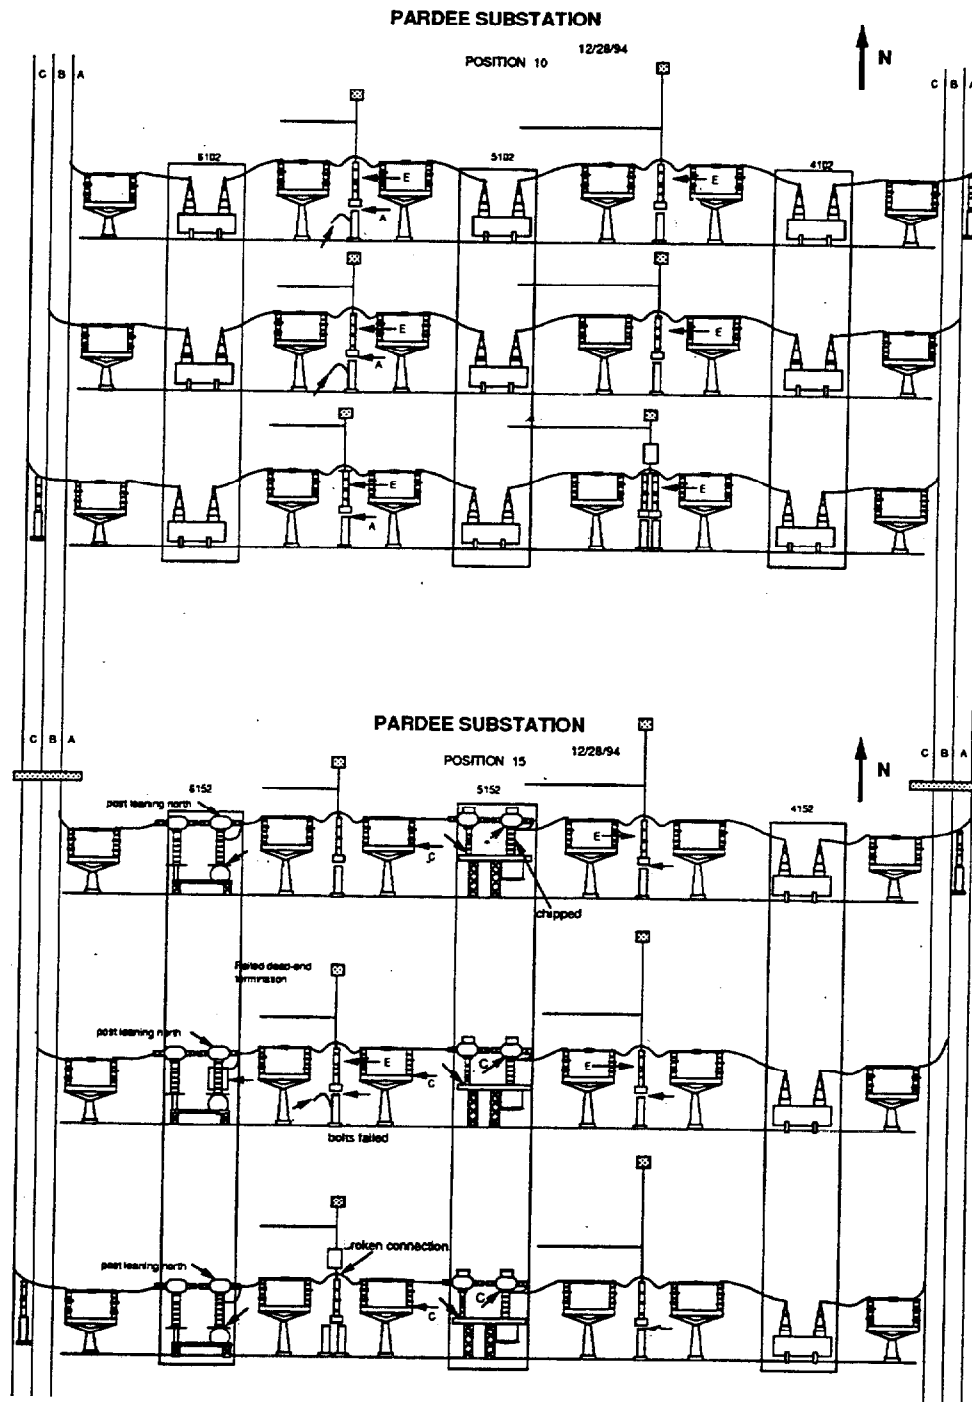
Fig. 3.64 Schematic diagram showing damage to 230 kV switchyard at Pardee Substation - Part 1.

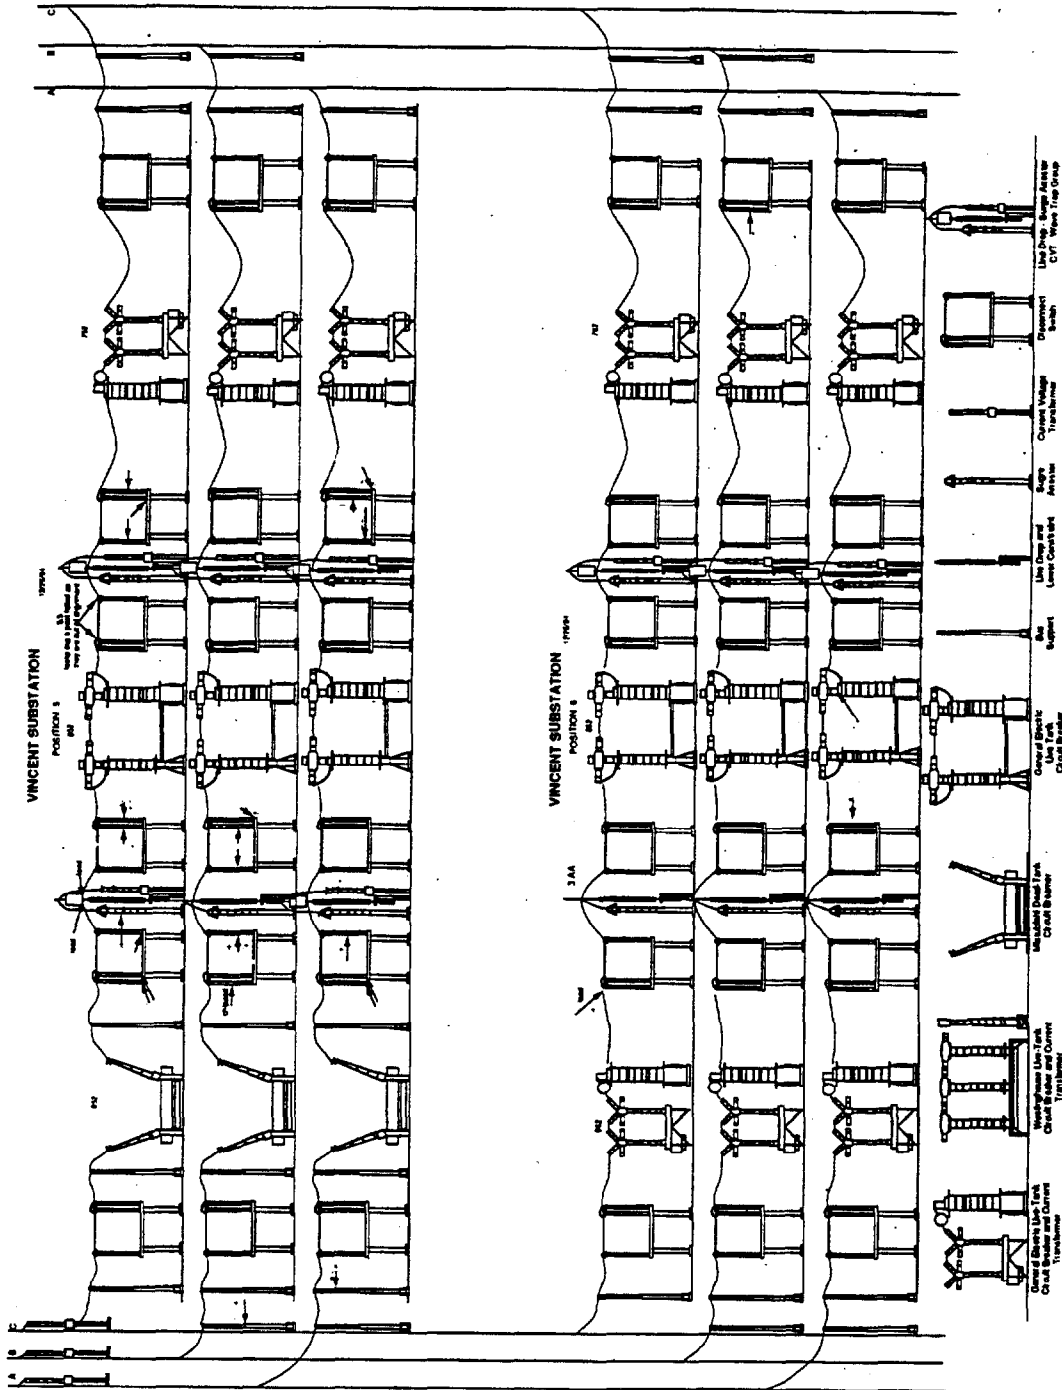
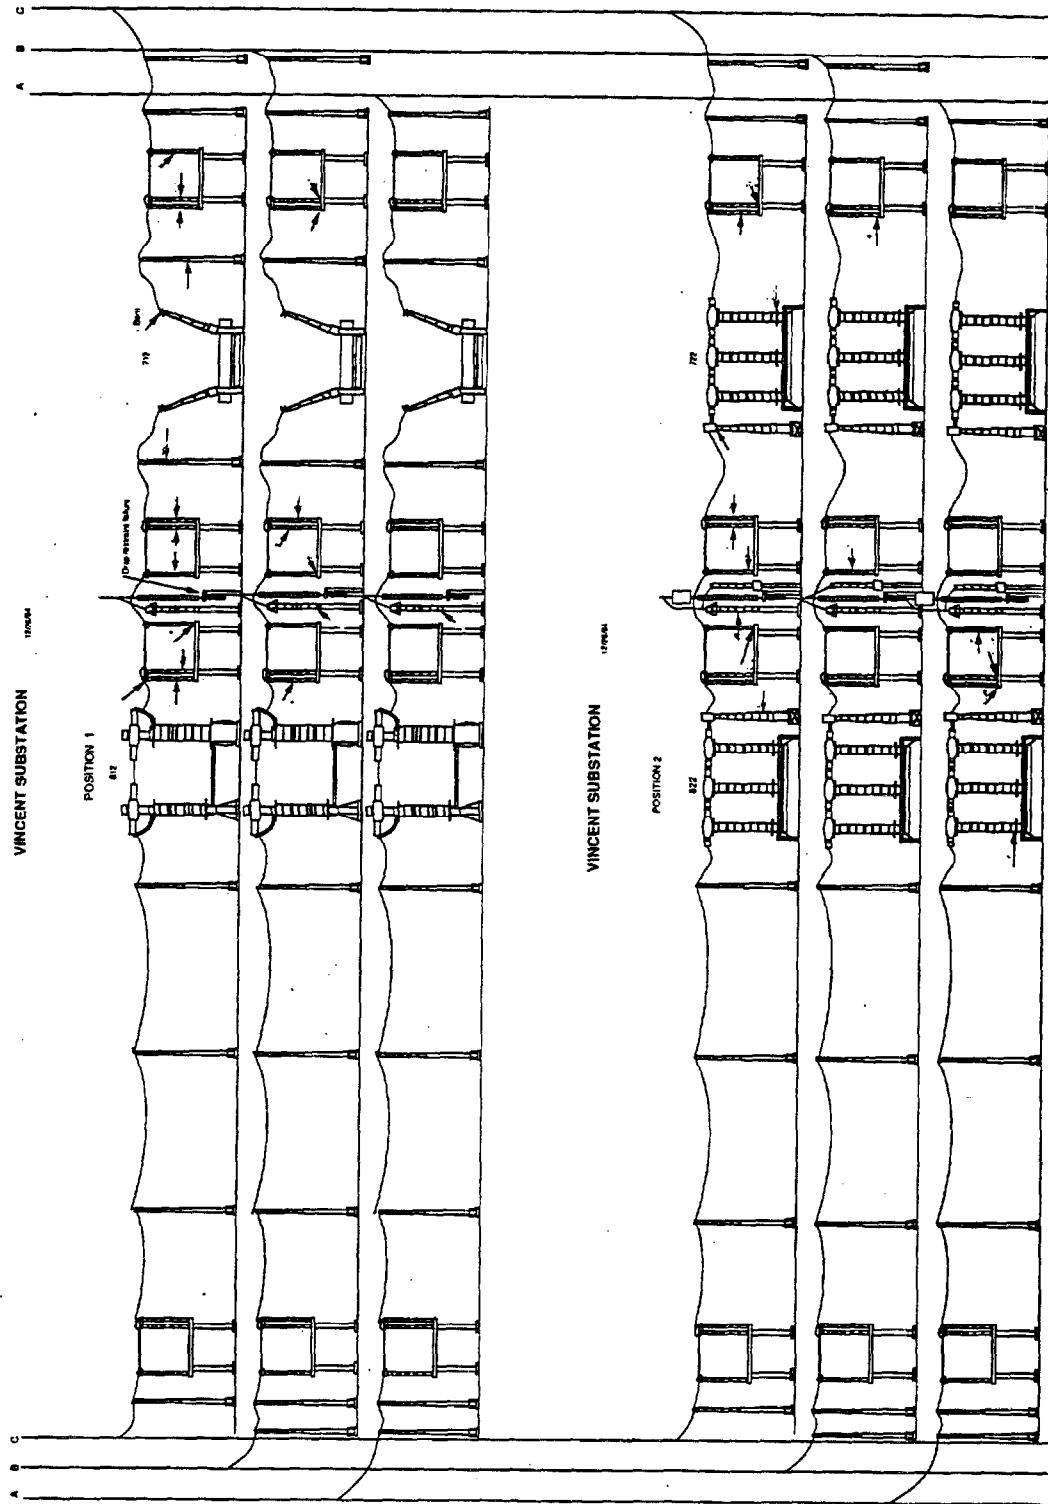
Fig. 3.66 Schematic diagram showing damage to 500 kV switchyard at Vincent Substation - Part 1.

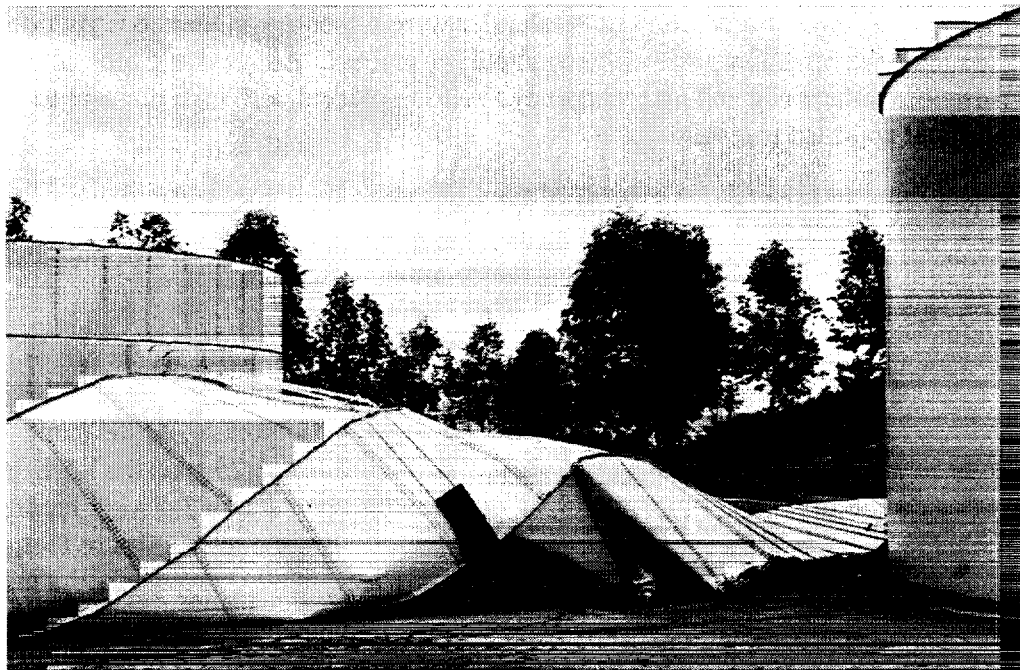
Similarly, there were two structural failures in the Valencia area, with a third tank suffering damage from an adjacent tank failure, Figs. 4.19 and 4.20. Failure modes were severe shell buckling and uplift, inlet-outlet piping failure, roof/rafter damage and in one case shell ripping at the tank bottom, Figs. 4.21 and 4.22. The two tanks with structural failures have been removed. Figure 4.23 shows a tank with a damage roof and upper walls and one of seven temporary portable Baker tanks.

Fig. 4.19 Collapsed 0.50 mg bolted steel tank (MM I) in Valencia area. MM II, at the left, was damaged by outflow from MM I. Large tank to right was undamaged. (T. Cooper)

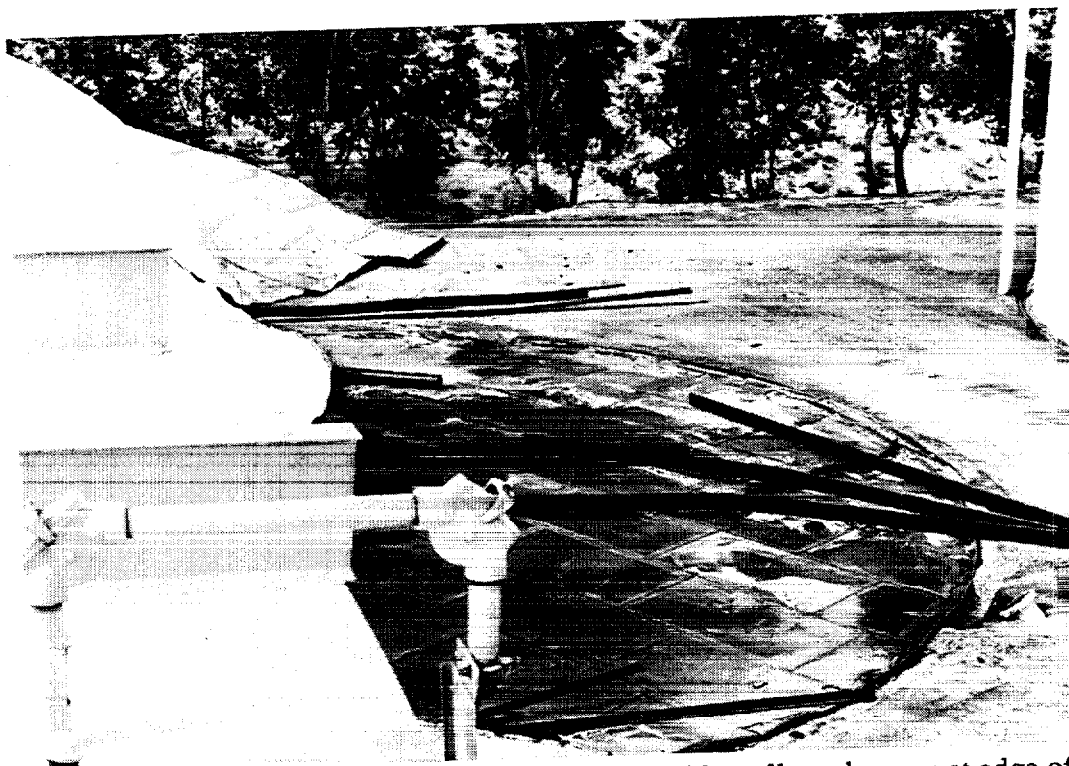
Fig. 4.20 Floor of collapses bolted tank. Tear in side wall can be seen at edge of base. (T. Cooper)

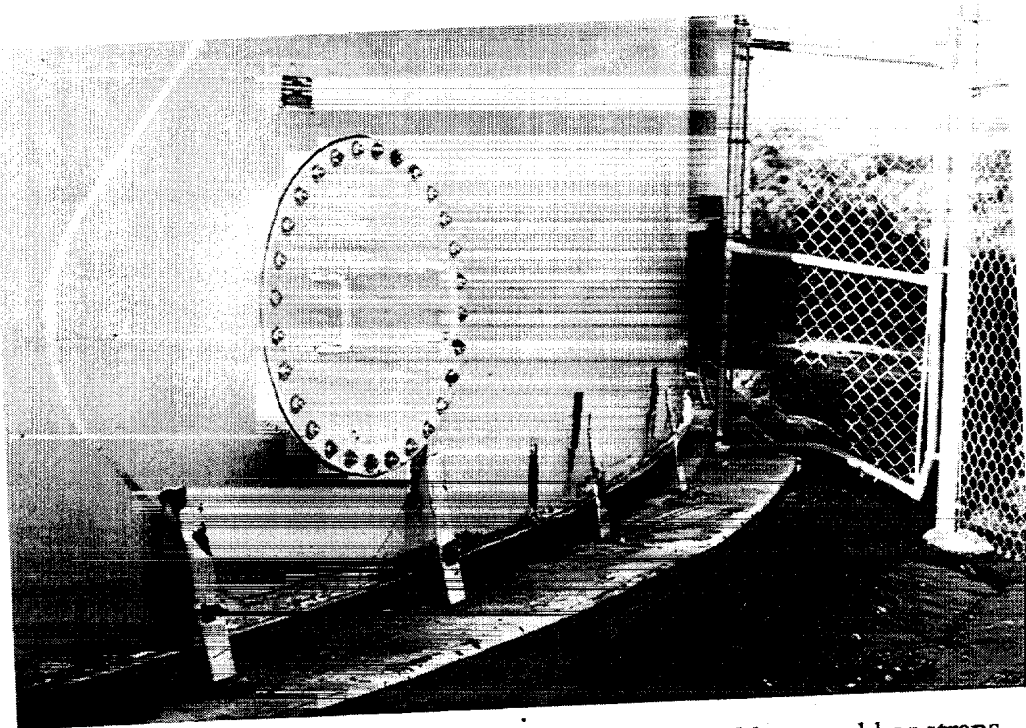
Fig. 4.22 Opposite side of tank shown in Fig. 4.2. Welds at anchor straps failed. (T. Cooper)

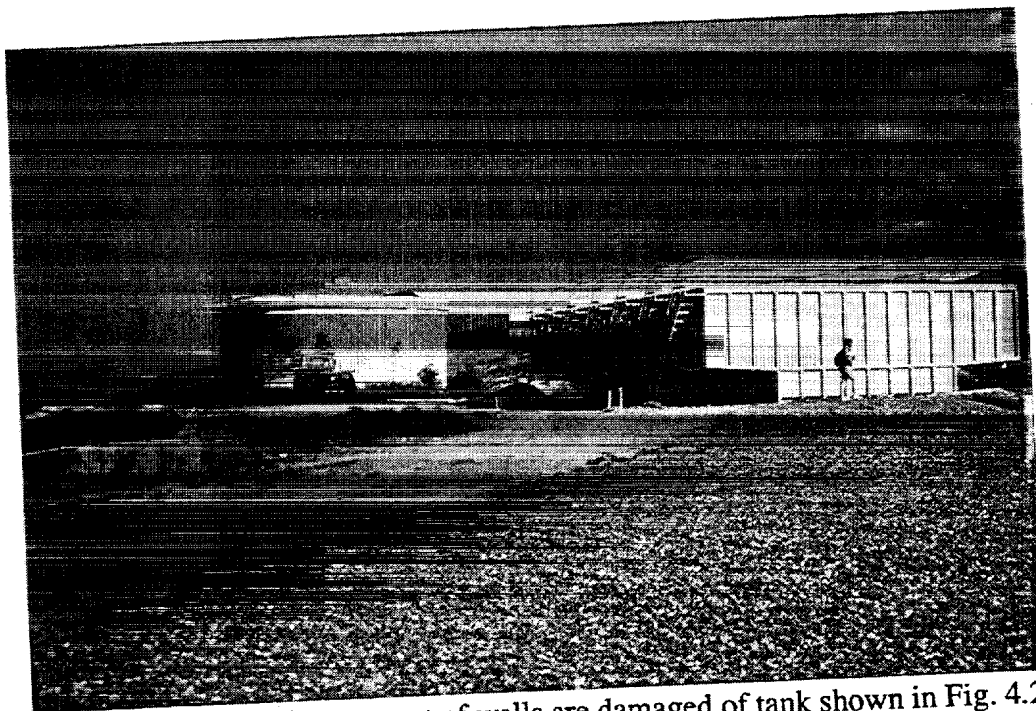
Fig. 4.23 Roof and upper part of walls are damaged of tank shown in Fig. 4.21. Temporary portable tank can be seen at left.

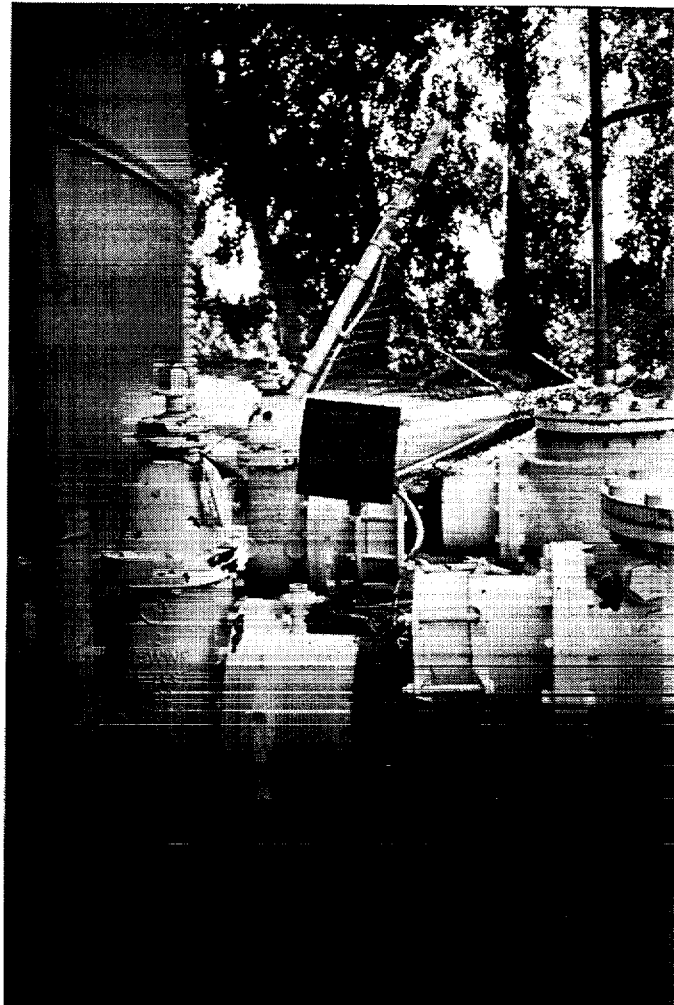
Tanks in the San Fernando Valley which had significant damage were in the Santa Monica Mountains south of Northridge. Inlet-outlet piping and valve damage, Fig. 4.24, erosion, Fig. 4.25 and roof problems, Fig. 4.26, were again the major causes of functional failure. All of these tanks have been repaired and returned to service. A damaged 1929 riveted steel tank in the Granada hills area has been removed.

Fig. 4.24 Dresser coupling failed at the tank inlet and outlet. (A. Gibson))

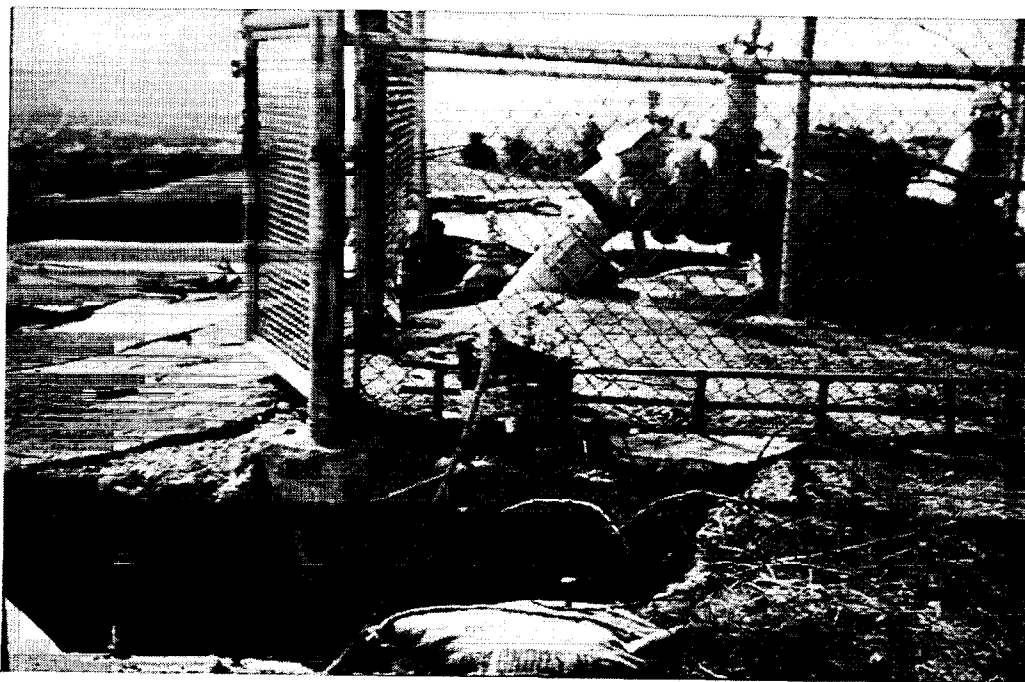
Fig. 4.25 Typical ground erosion from tank draining. (LADWP)

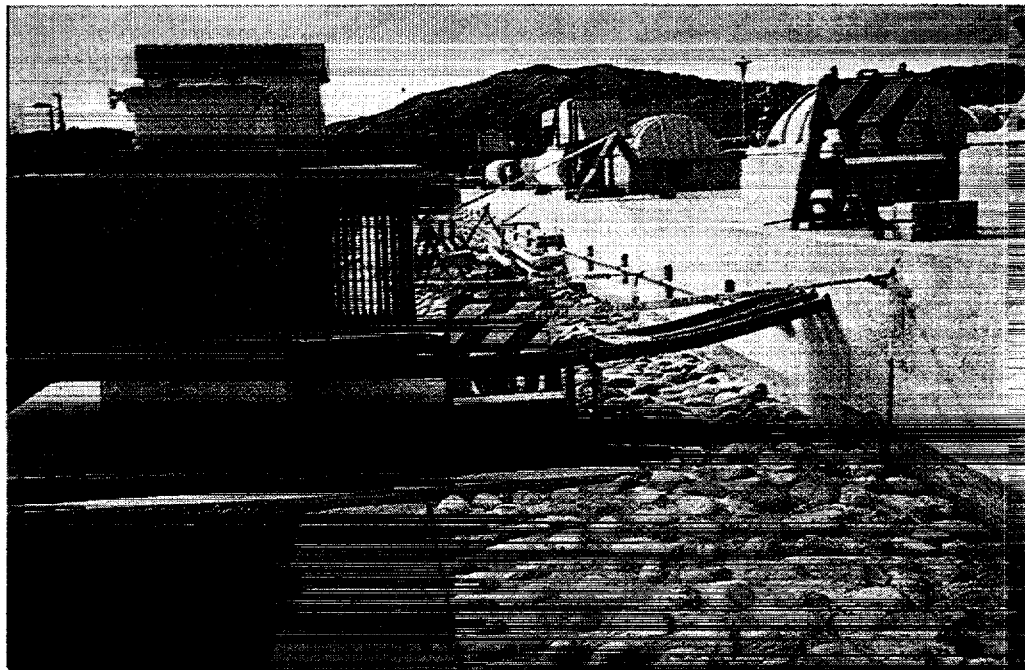
Fig. 4.28 Ground settlement adjacent to water treatment plant (U. of Tokyo)

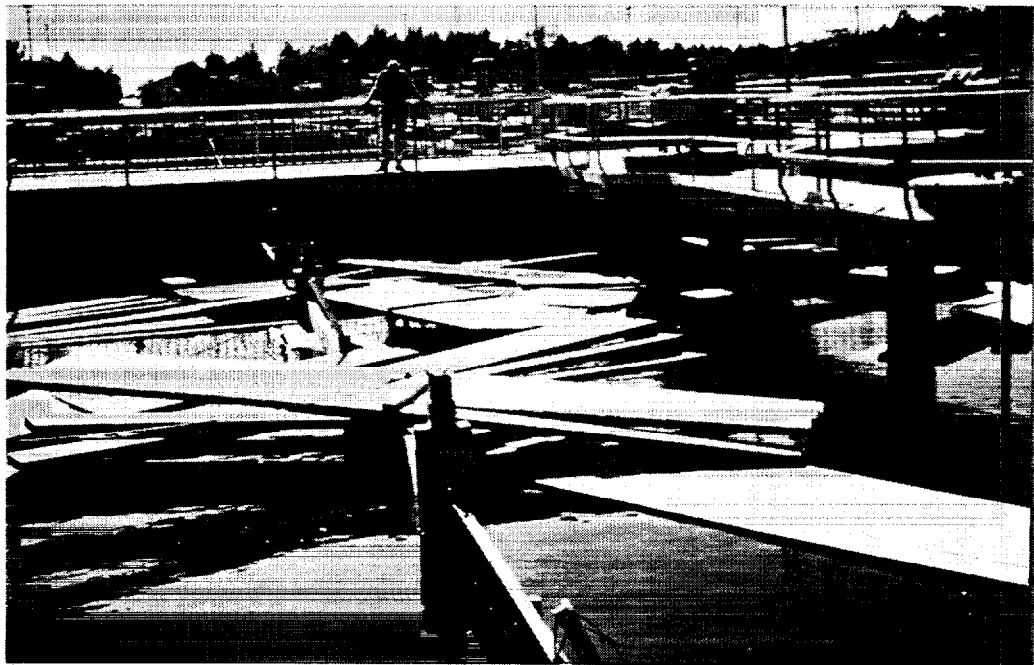
Fig. 4.32 Wood baffles damaged by sloshing at water treatment plant. (MWD)

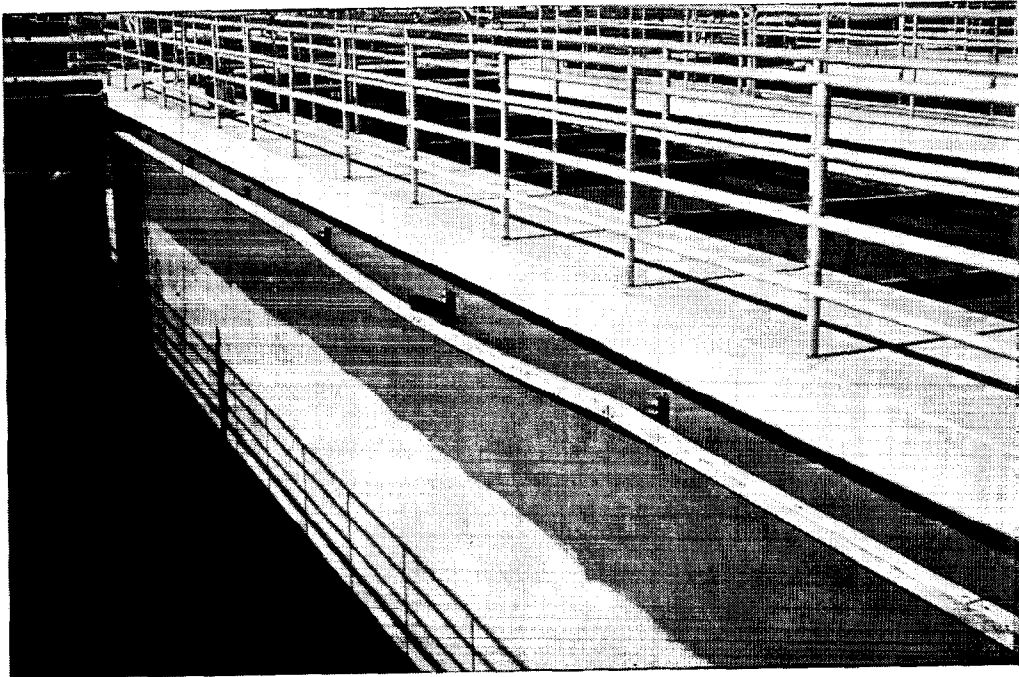
Fig. 5.5 Tillman plant final clarifier, sloshing unseated return sludge scraper chain rail.

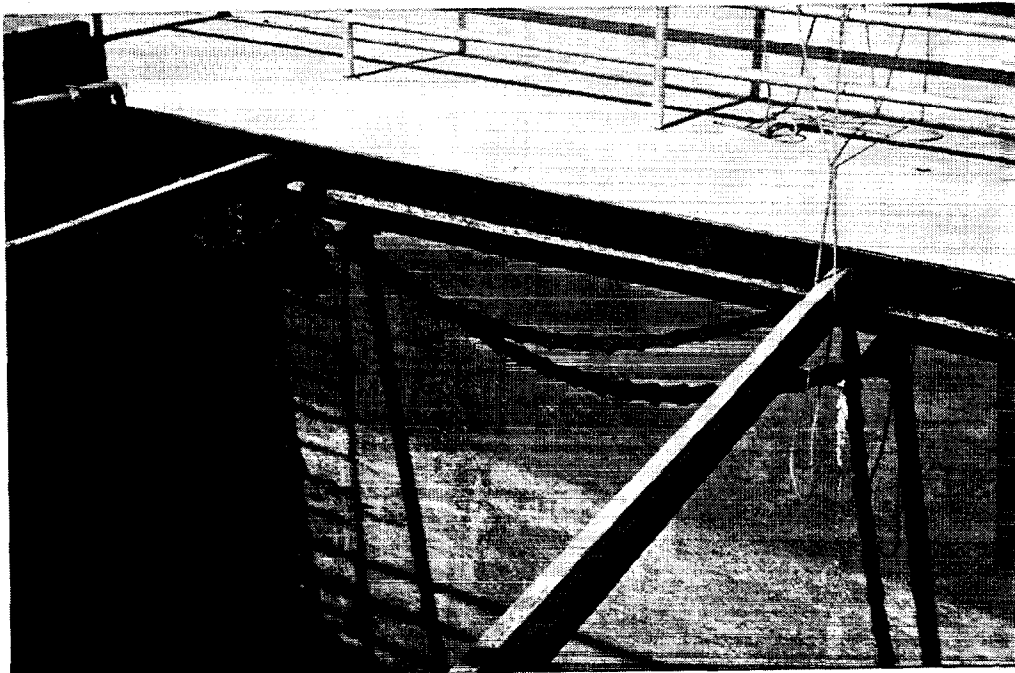
Fig. 5.6 Tillman plant final clarifier. Sloshing jammed sludge scraper chain drive.

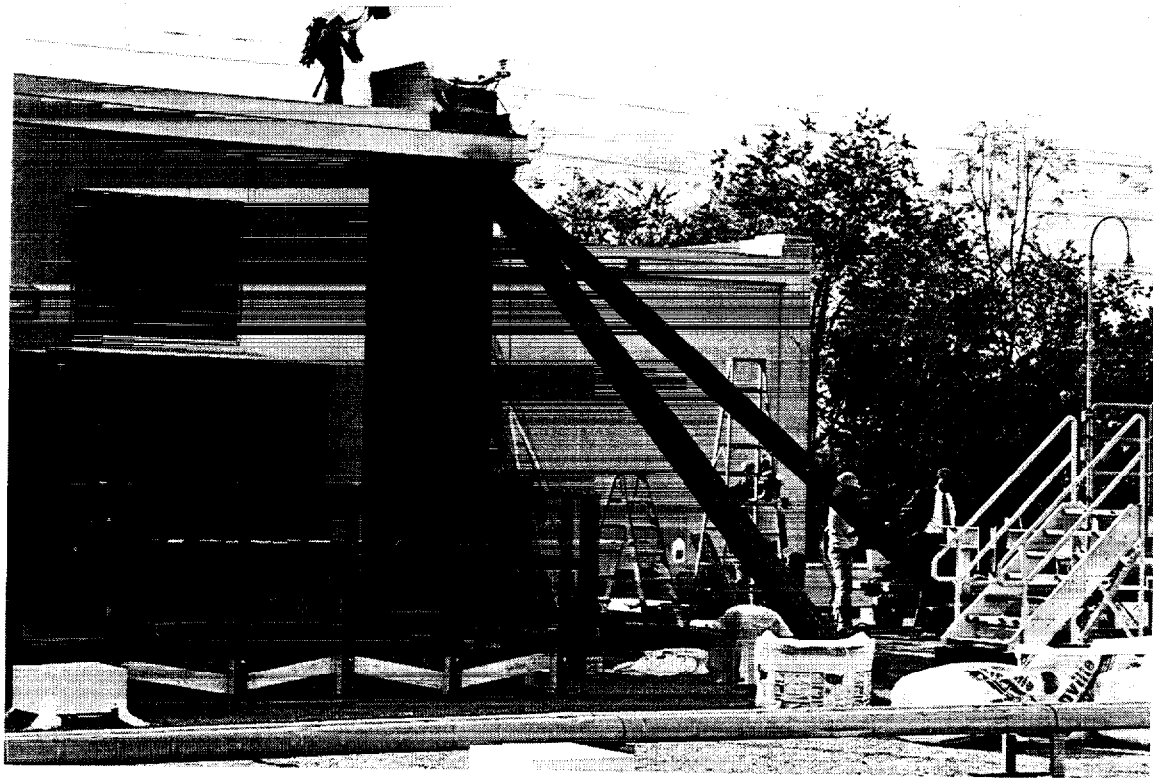
Fig. 6.3. Shoring up structural damage to a central office building.

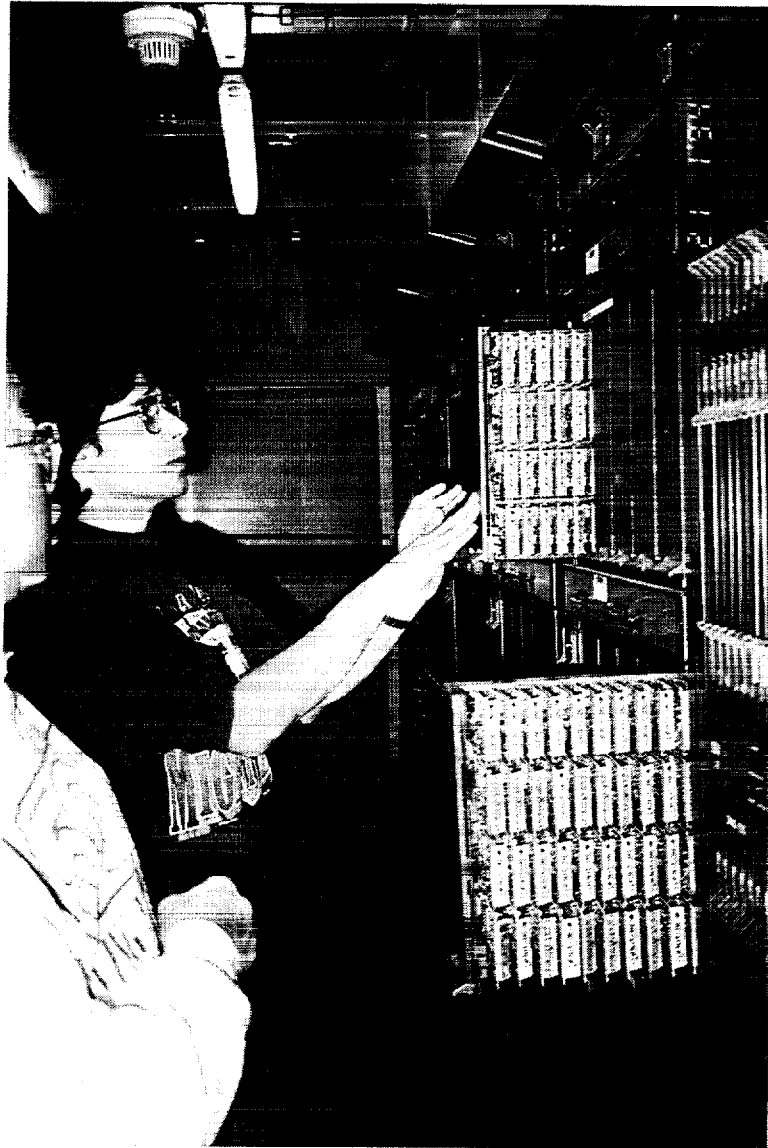
Fig. 6.4. Line disruption due to unseated or damaged circuit boards.

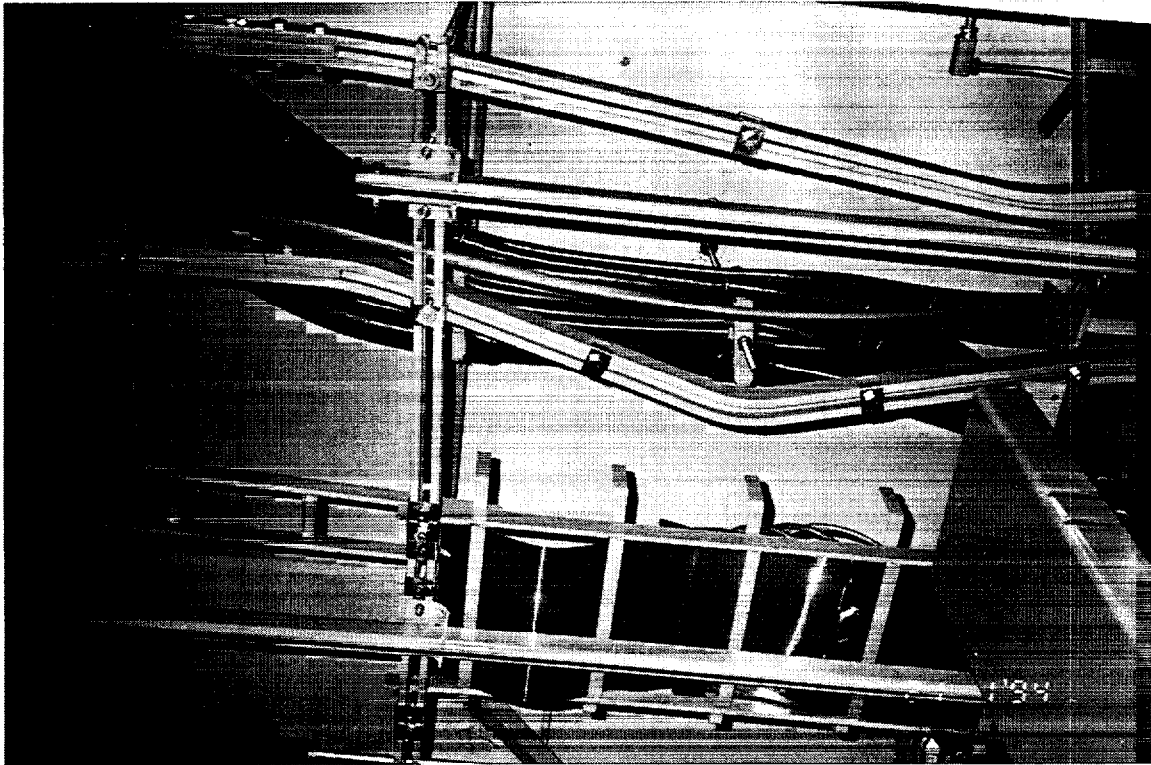
Figure 6.5. Buckled bars in overhead ironworks.
